Commission Meeting

FEBRUARY 13TH, 2024

Item 4 - Turbine 3 Overhaul Update

REPAIR RECOMMENDATIONS LETTER

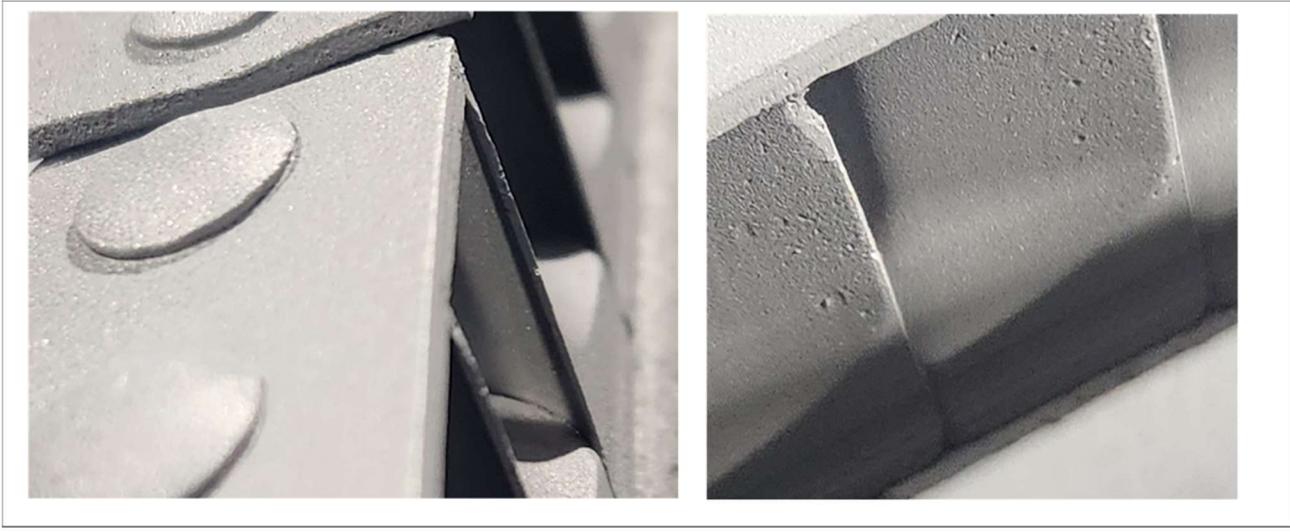
Many of the blades were identified with severe impact damage. There is found to be a significant amount of pitting and erosion on the admission and exhaust side of the airfoils and covers, as well as thin leading and trailing edges.

Repair Recommendations:

Highly recommend replacement of all blades to return them to OEM specifications, improved equipment reliability, and predictable power generation.

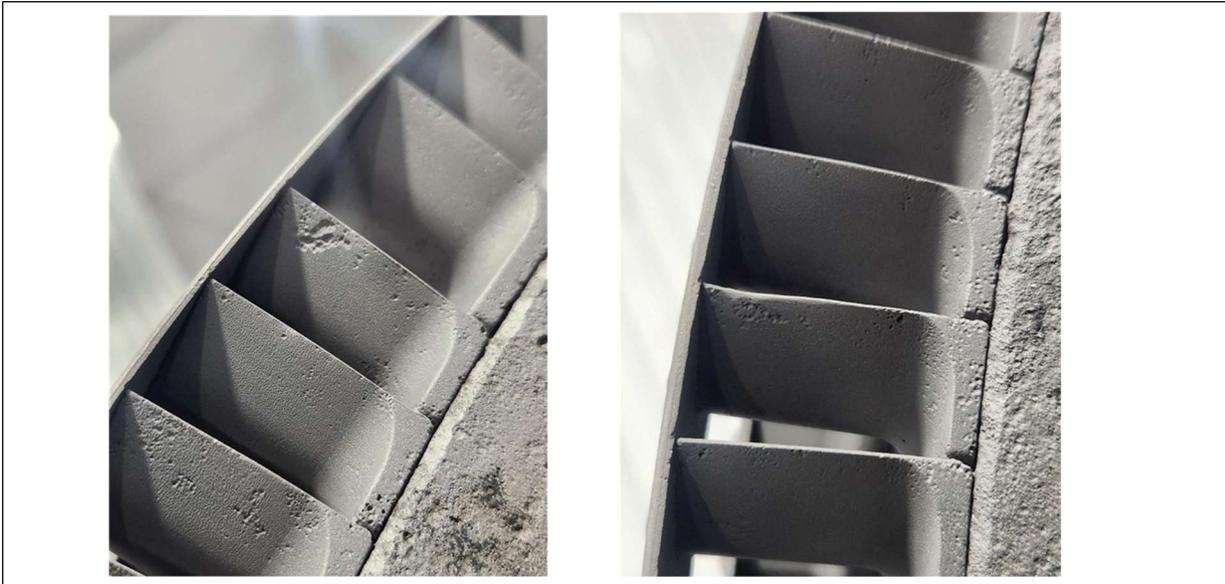
Additionally, the covers on the exhaust side of groups 4, 5, 6, 7, and 8, are no longer flush to the airfoils (lifted approx. .100”) and separating from many of the tenons.

Repair Recommendations:

Option 1:

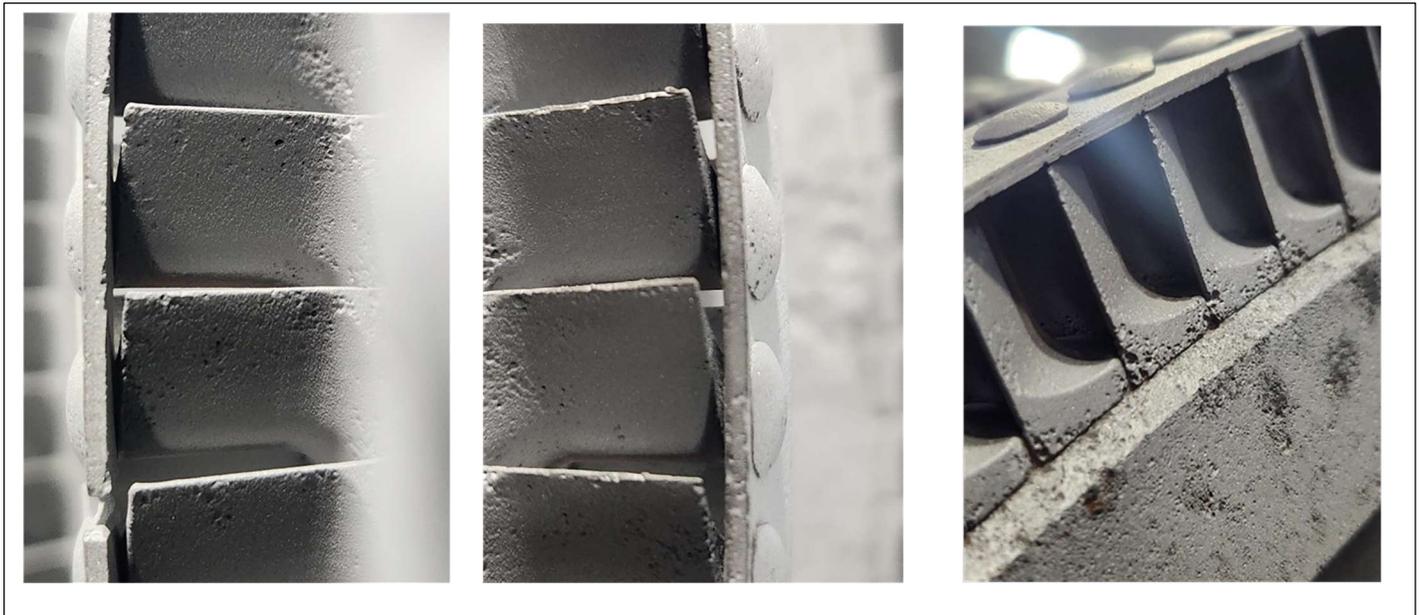
Many of the blades were identified with moderate impact damage. There is found to be a significant amount of pitting and erosion on the admission and exhaust side of the airfoils and covers, as well as thin leading and trailing edges.

Repair Recommendations:

Highly recommend replacement of all blades to return them to OEM specifications, improved equipment reliability, and predictable power generation.

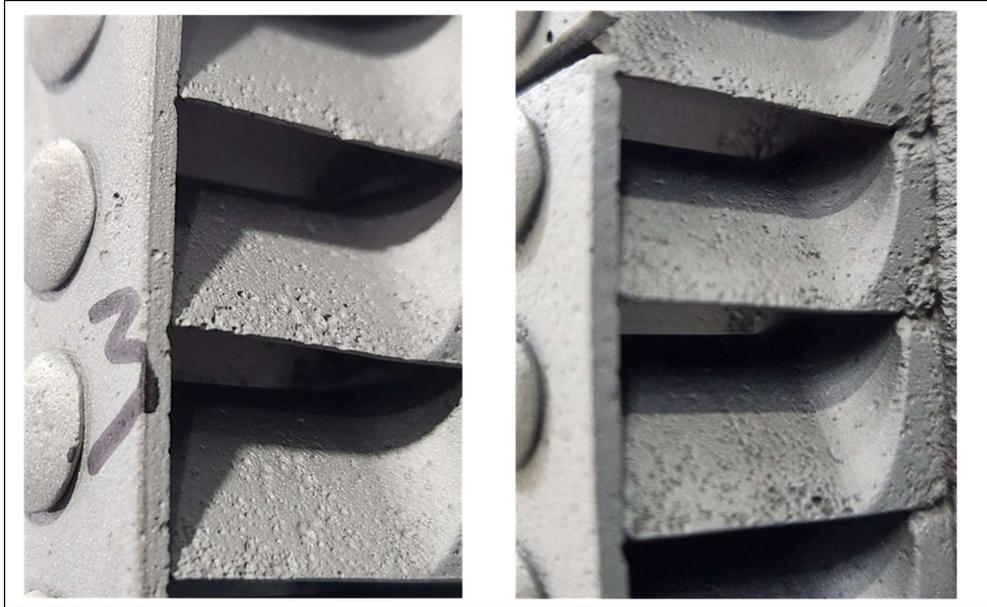
Many of the blades were identified with moderate impact damage. There is found to be a significant amount of pitting and erosion on the admission and exhaust side of the airfoils and covers, as well as thin leading and trailing edges.

Repair Recommendations:

Highly recommend replacement of all blades to return them to OEM specifications, improved equipment reliability, and predictable power generation.

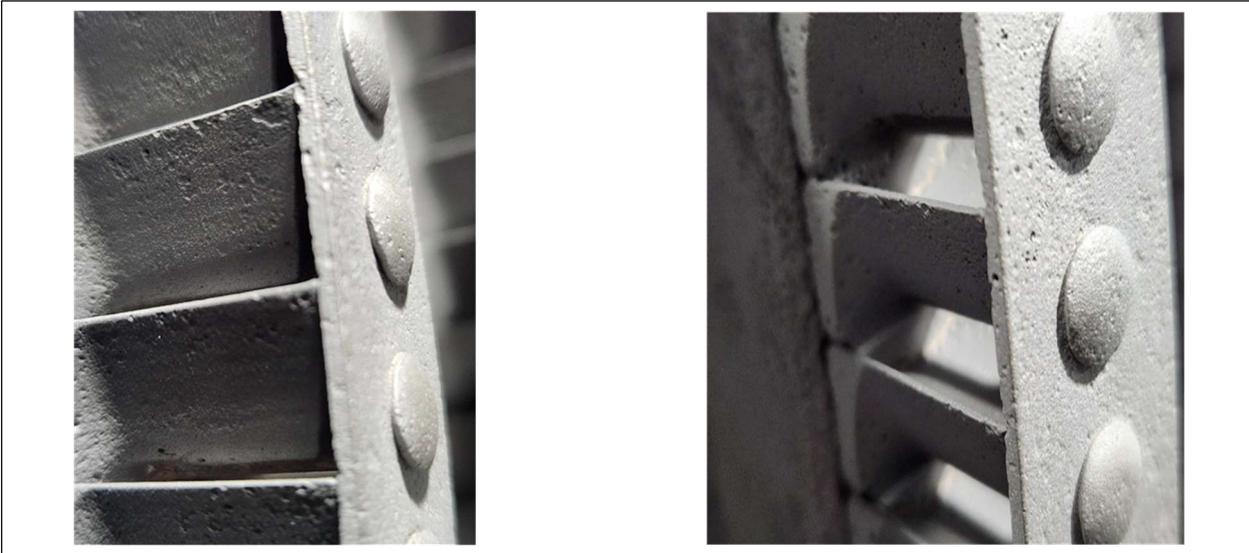
Many of the blades were identified with moderate impact damage. There is found to be a significant amount of pitting and erosion on the admission and exhaust side of the airfoils and covers, as well as thin leading and trailing edges.

Repair Recommendations:

Highly recommend replacement of all blades to return them to OEM specifications, improved equipment reliability, and predictable power generation.

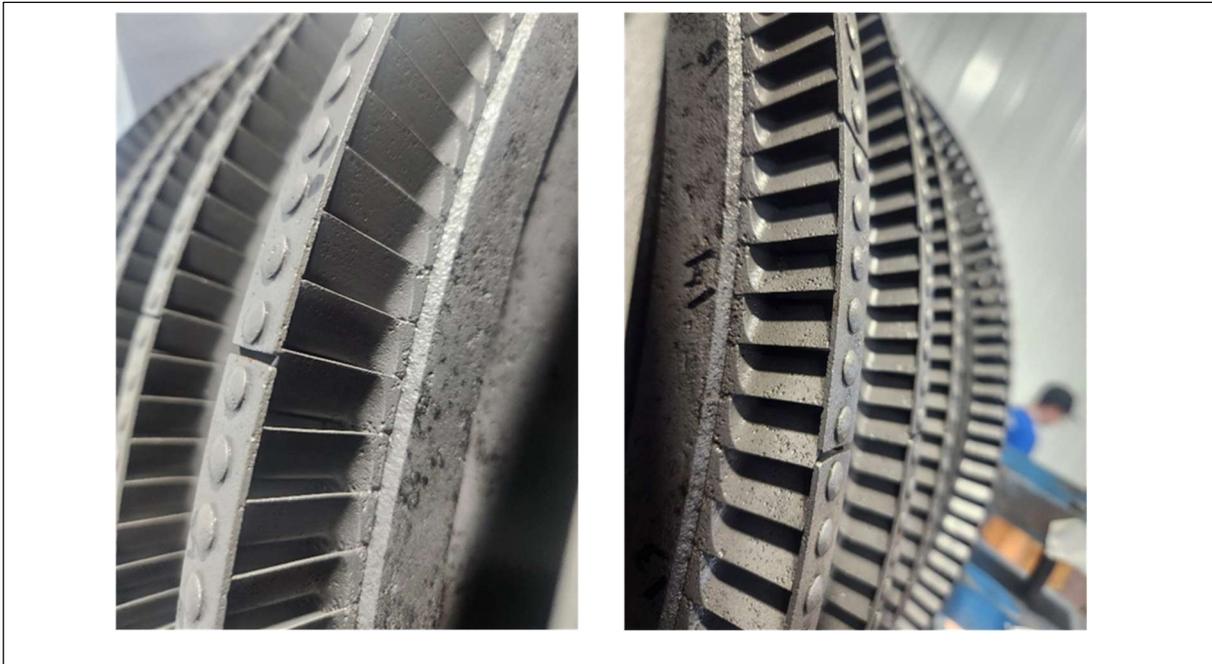
Many of the blades were identified with moderate impact damage. There is found to be a significant amount of pitting and erosion on the admission and exhaust side of the airfoils and covers, as well as thin leading and trailing edges.

Repair Recommendations:

Highly recommend replacement of all blades to return them to OEM specifications and ensure the utmost, integrity, efficiency, and megawatt output.

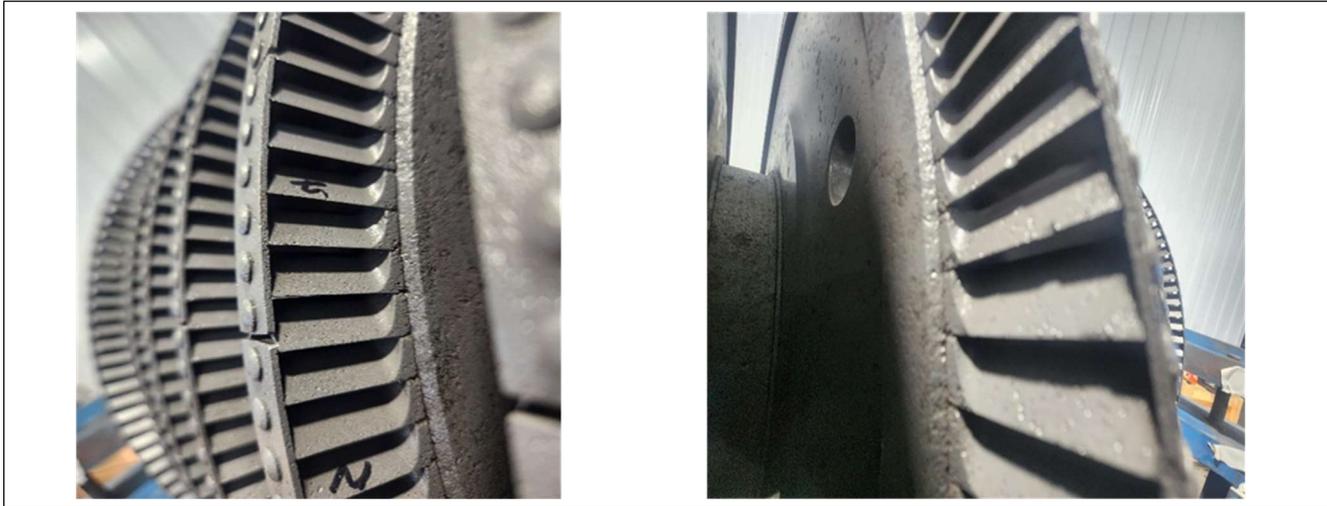
Many of the blades were identified with moderate impact damage. There is found to be a significant amount of pitting and erosion on the admission and exhaust side of the airfoils and covers, as well as thin leading and trailing edges.

Repair Recommendations:

Highly recommend replacement of all blades to return them to OEM specifications, improved equipment reliability, and predictable power generation.

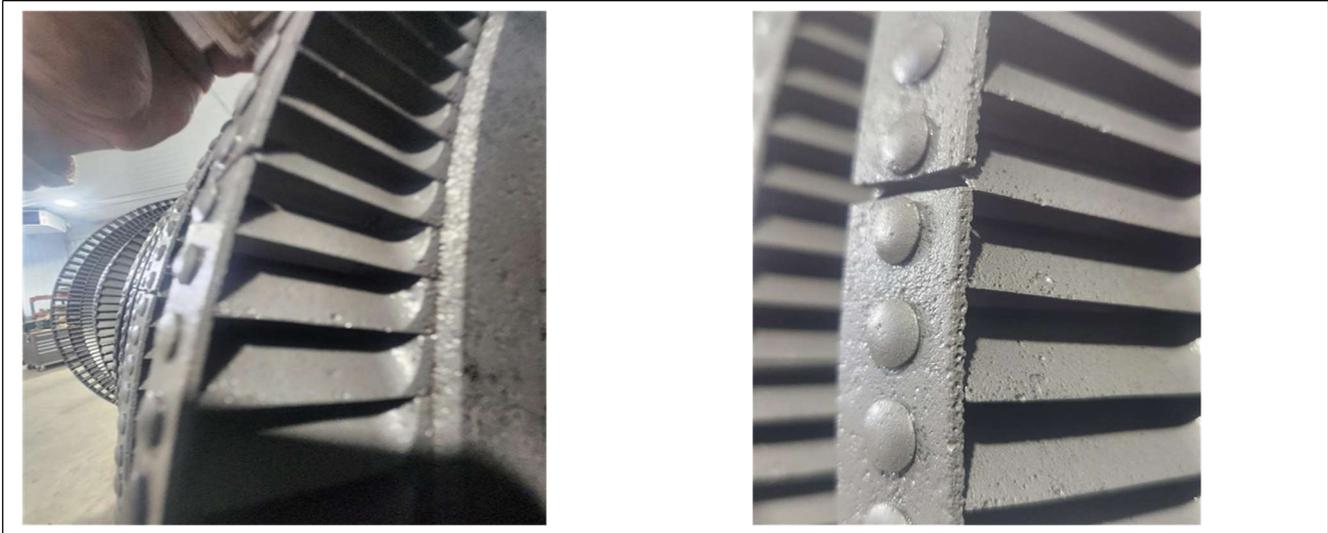
Many of the blades were identified with severe impact damage. There is found to be a significant amount of pitting and erosion on the admission and exhaust side of the airfoils and covers, as well as thin leading and trailing edges.

Repair Recommendations:

Highly recommend replacement of all blades to return them to OEM specifications, improved equipment reliability, and predictable power generation.

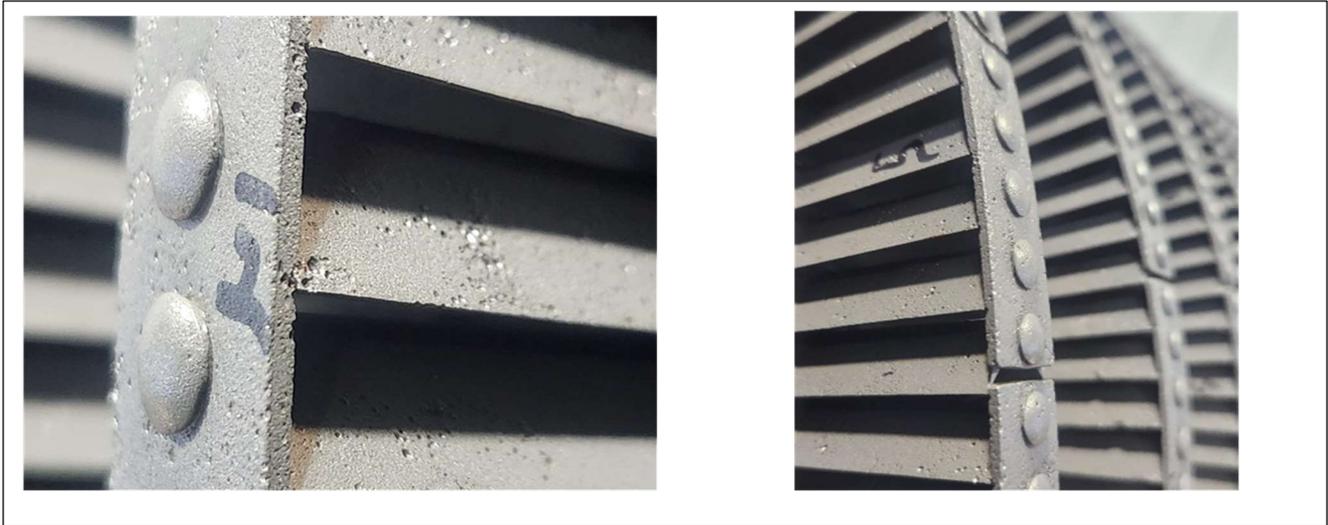
Many of the blades were identified with moderate impact damage. There is found to be a significant amount of pitting and erosion on the admission and exhaust side of the airfoils and covers, as well as thin leading and trailing edges. Additionally, there are covers that have pieces missing and a few blades were found to have previously had issues with cracking and were ground out. This previous repair has greatly affected the overall integrity of the airfoils.

Repair Recommendations:

Highly recommend replacement of all blades to return them to OEM specifications, improved equipment reliability, and predictable power generation.

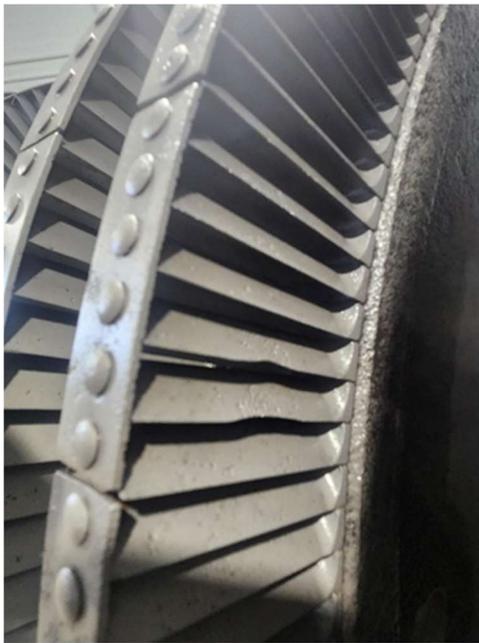
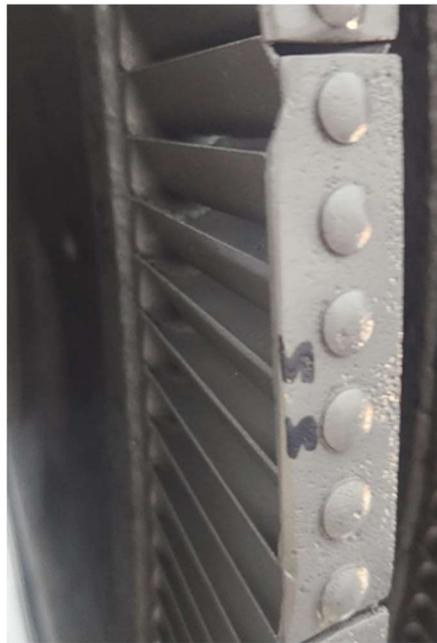
Many of the blades were identified with severe impact damage. There is found to be a significant amount of pitting and erosion on the admission and exhaust side of the airfoils and covers, as well as thin leading and trailing edges.

Repair Recommendations:

Highly recommend replacement of all blades to return them to OEM specifications, improved equipment reliability, and predictable power generation.

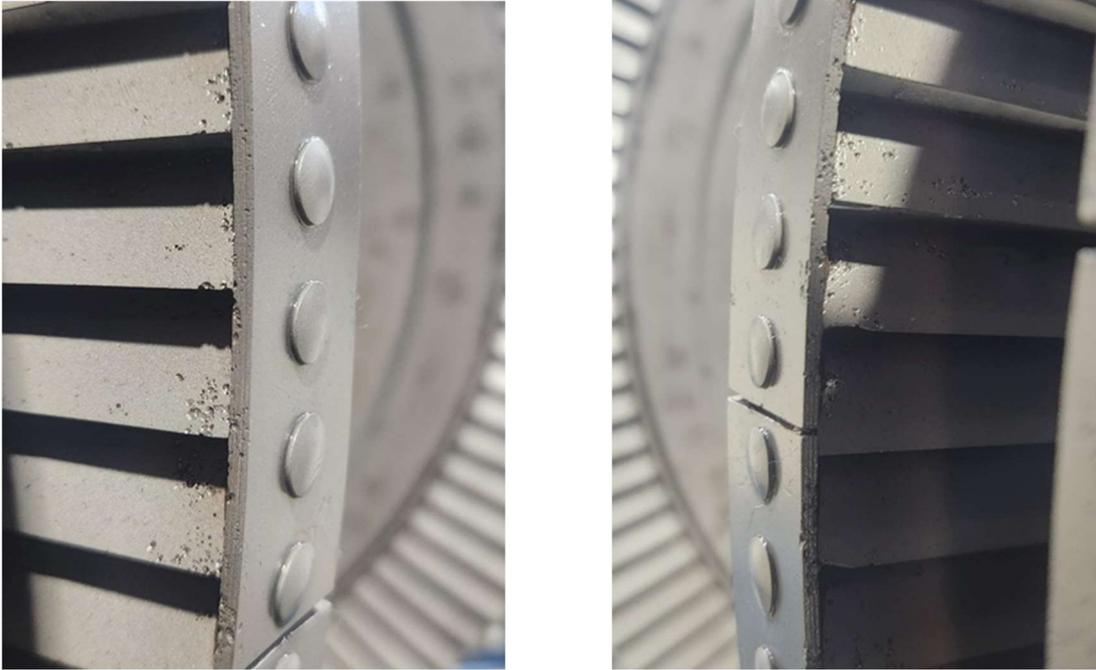
Many of the blades were identified with moderate impact damage. There is found to be a significant amount of pitting and erosion on the admission and exhaust side of the airfoils, as well as thin leading and trailing edges.

Repair Recommendations:

Option 1:

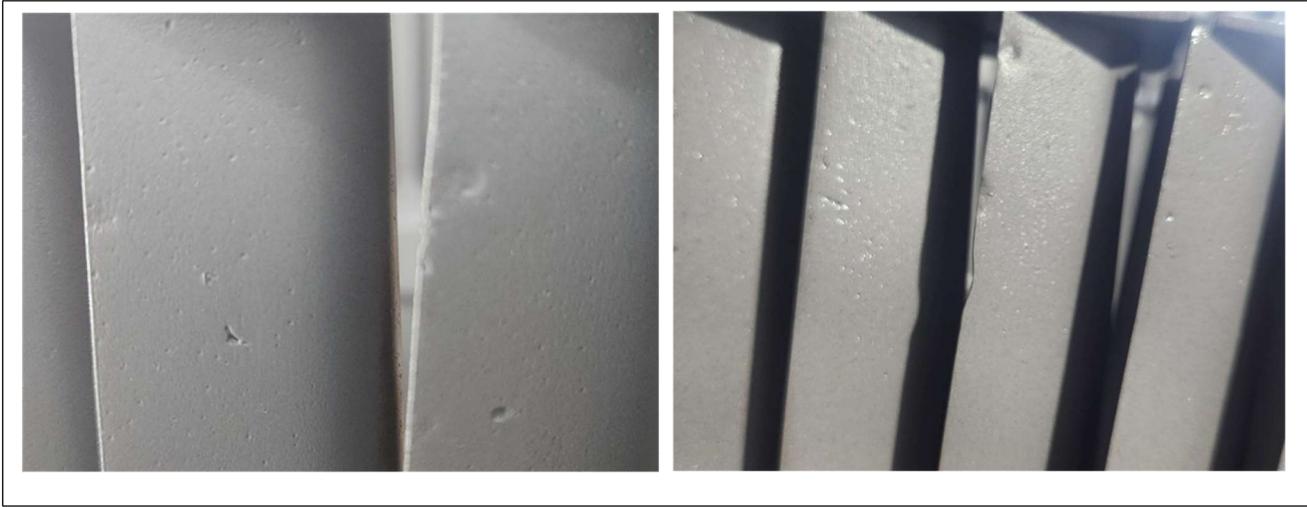
Many of the blades were identified with severe impact damage. There is found to be a significant amount of pitting and erosion on the admission and exhaust side of the airfoils, as well as thin leading and trailing edges.

Repair Recommendations:

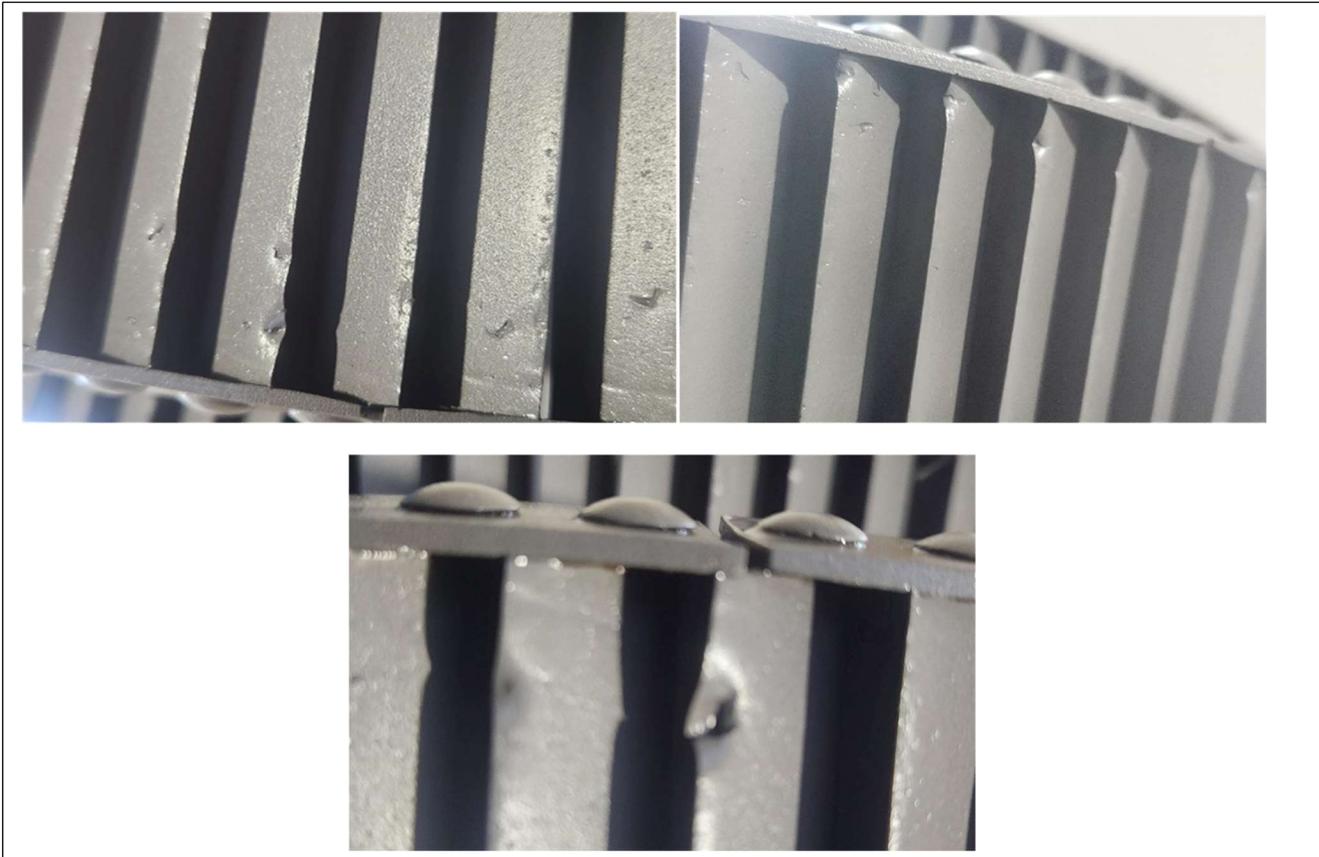
Many of the blades were identified with moderate impact damage. There is found to be a significant amount of pitting and erosion on the admission and exhaust side of the airfoils, as well as thin leading and trailing edges.

Repair Recommendations:

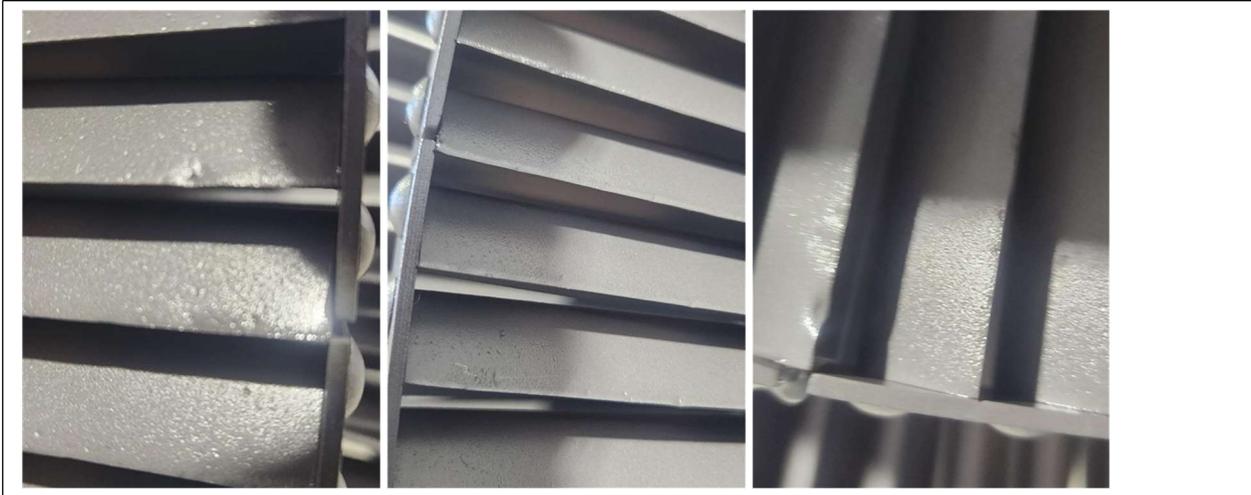
Admission side of the Airfoils are found to be pitted and eroded, most significant at the trailing edge.

Repair Recommendations:

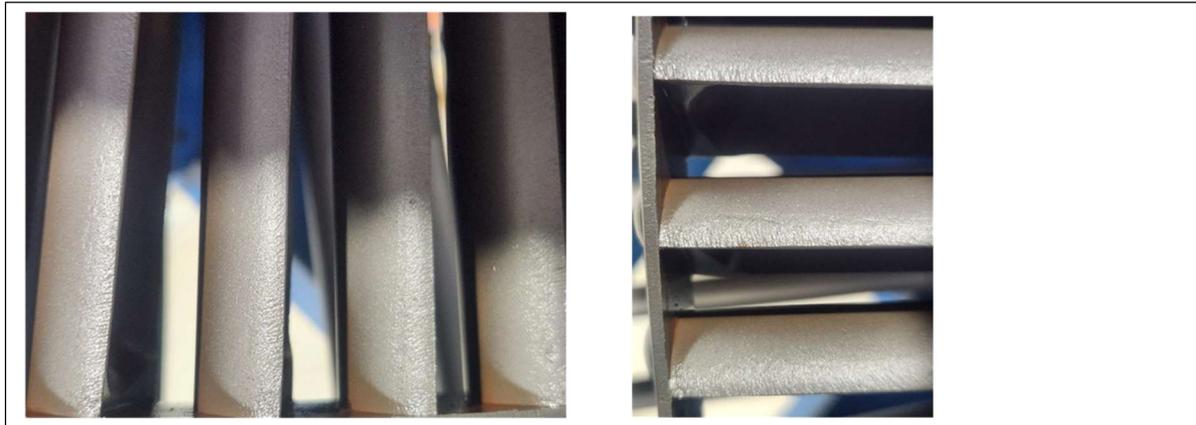
All erosion shields are severely eroded and “cutting” into the admission side of the airfoil, in addition to steam cutting the airfoil next to the cover.

Repair recommendation:

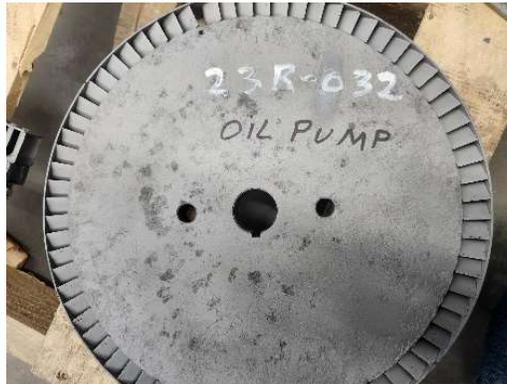
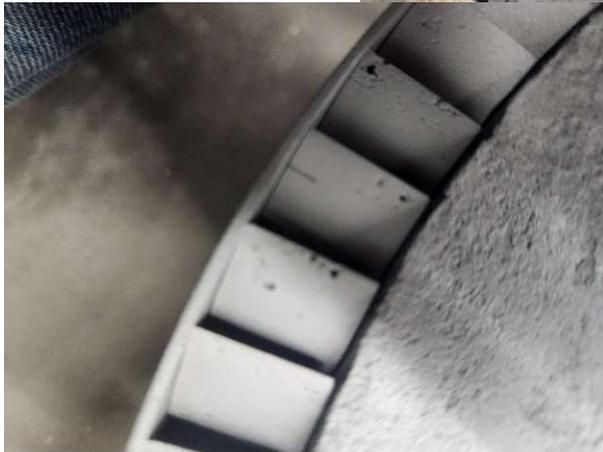
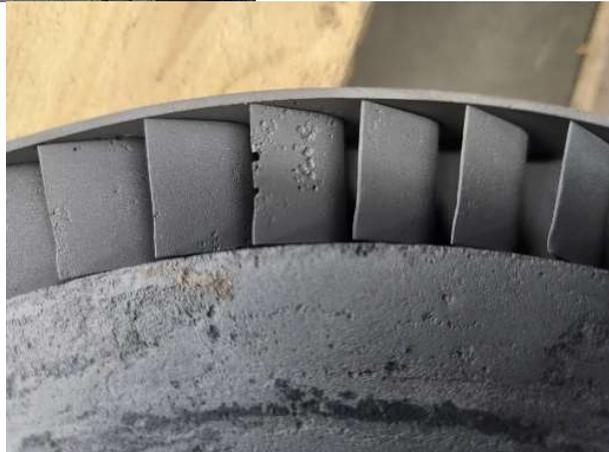
The majority of the blades were identified with a significant amount of erosion, ranging from 0.030-0.050", on both the admission and exhaust side of the airfoils, in addition to extremely thin edges. There are many the partitions and covers, that are presenting with thru holes. The Wheel has a mild to moderate level of erosion.

Repair Recommendations:

Option 1:

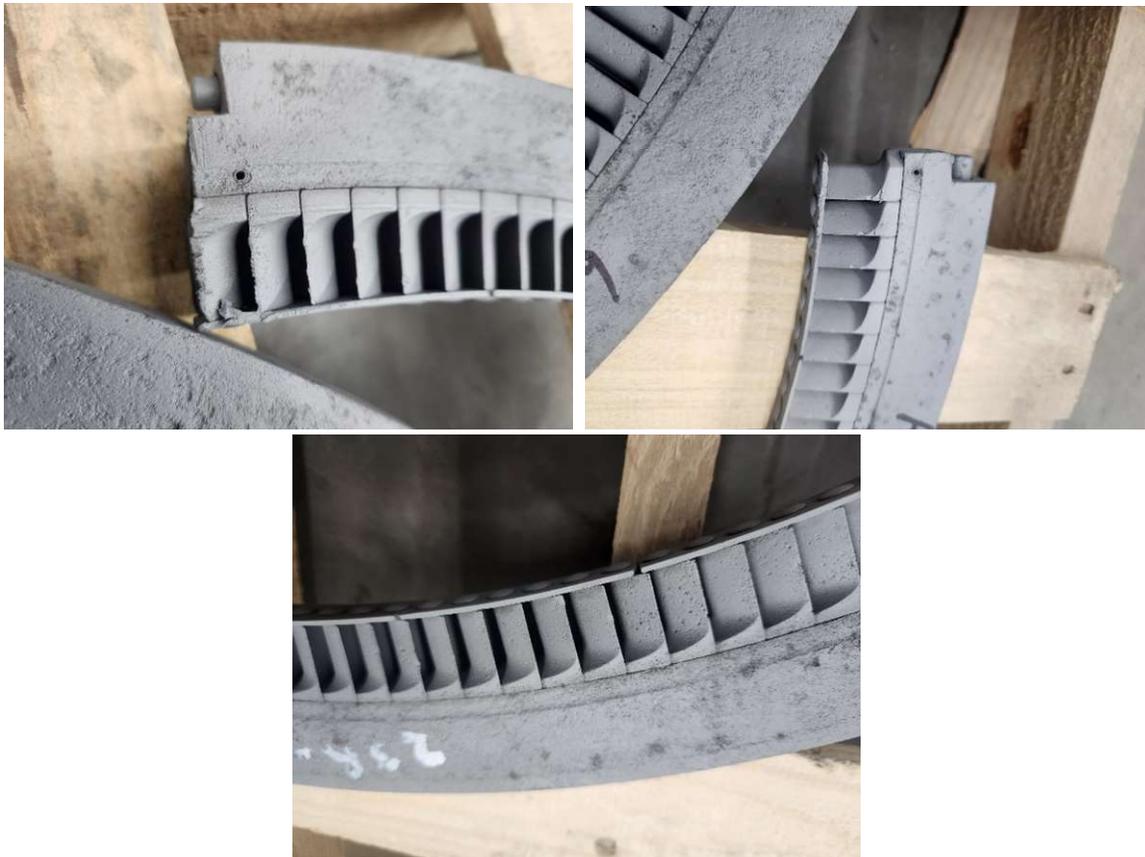
Many of the blades and covers were identified with a significant or extreme amount of damage to the lower half, most prevalent on the left side. This appears to be due to a “hard” rub while in service. Both the admission and exhaust side of the airfoils have extremely thin edges. There are many the blades and covers, that are presenting with pitting and thru holes.

Repair Recommendations:
