Loss of Scranton Well Hampering Economic Development

Water System Needs Over Next 10 Years

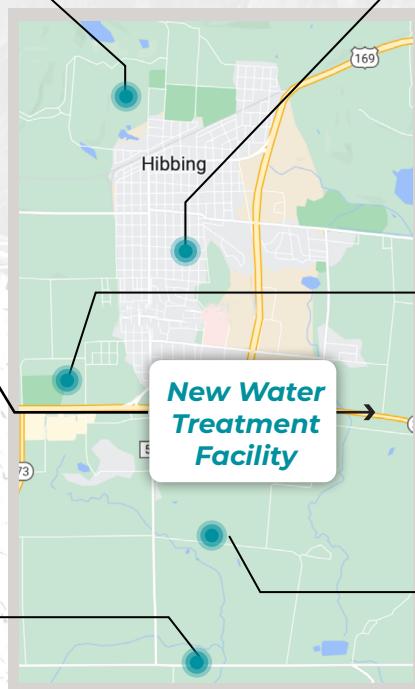
New Water Treatment Facility

The new water treatment facility is needed to treat water from the eastern wellfield. This wellfield was installed to replace supply lost by the Scranton well shutdown.

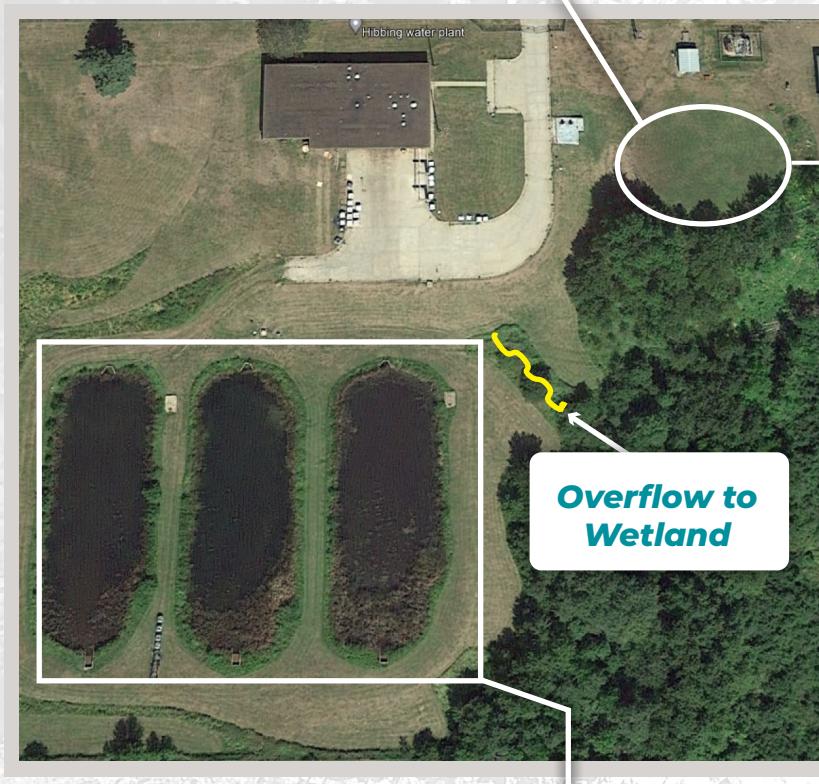
Deteriorating 100 Year Old Reservoir

The reservoir at the water treatment plant is over 100 years old. When inspected, it was discovered there is concrete falling into the bottom of the tank, indicating concrete failure of the top slab of the tank. This reservoir is critical to the water supply for Hibbing as there is no way to supply water to the City without this tank.

**Concrete Spalls
From The Tank Roof**

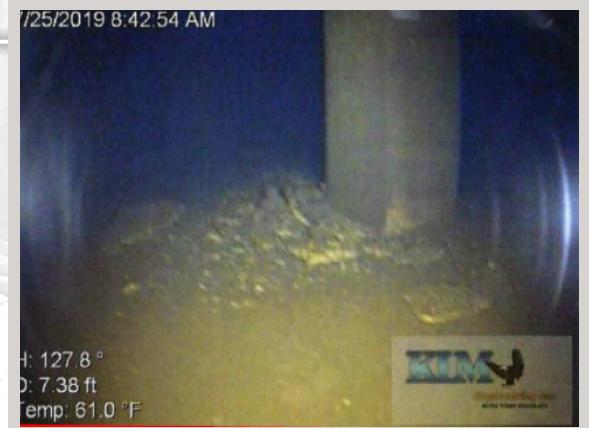
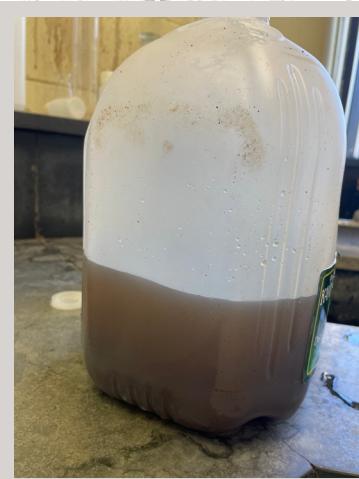
**Failing Backwash
System/Disposal**

Backwash water (shown left) flows to these three seepage basins.

The basins are failing, leading to overflows into a nearby wetland.
