Commission Meeting

FEBRUARY 13TH, 2024

Item 4 - Turbine 3 Overhaul Update

REPAIR RECOMMENDATIONS LETTER

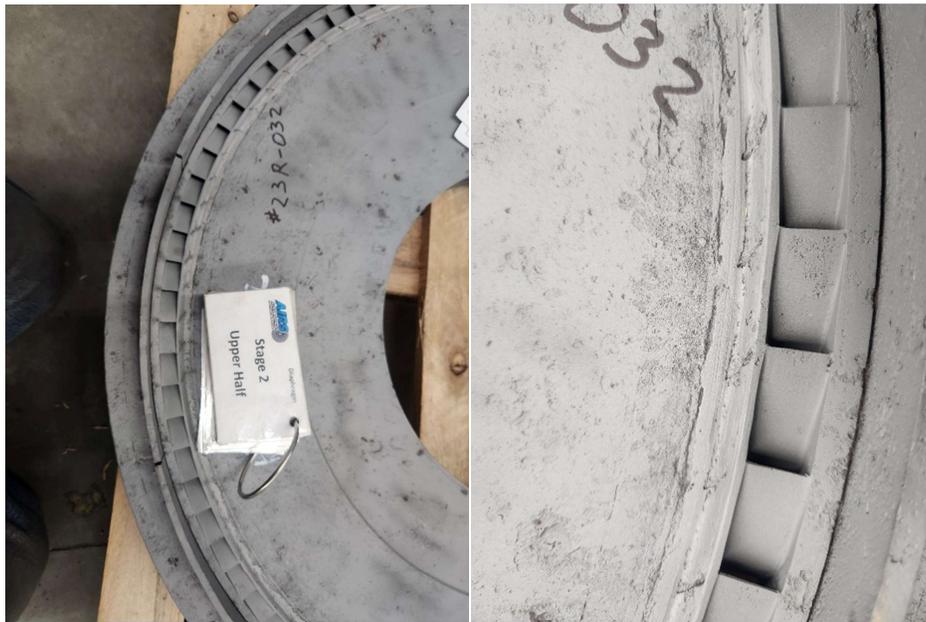
All partitions on the 2nd stage diaphragm have presented with minor amounts of pitting. The joint, packing hooks, and keys have a moderate amount of erosion. The steam sealing faces on the upper and lower half are severely eroded. There is one Packing Bolt on the Upper Half that was broken prior to arrival at the AIRS Facility.

- Light Polish only all blades. (No bench backs to be performed.)
- Drill out broken packing bolt and retap.

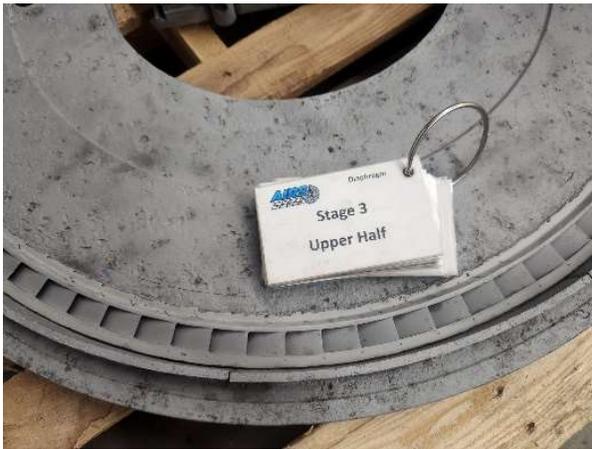
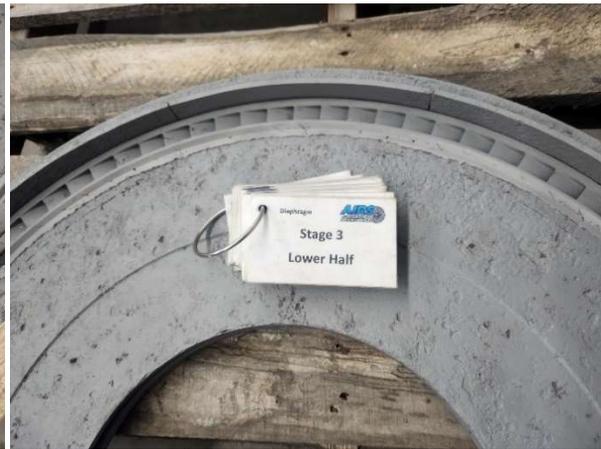
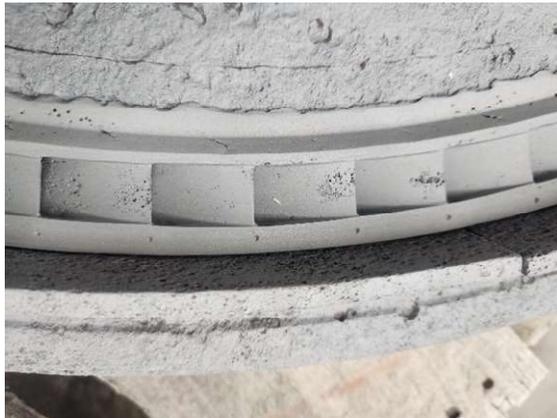
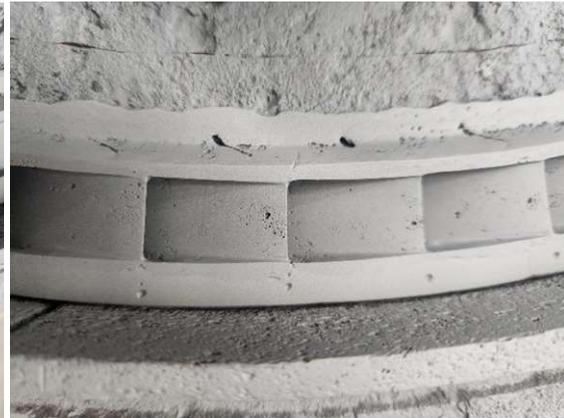
All partitions on the 3rd stage diaphragm are presenting with minor amounts of pitting. The joint, packing hooks, and keys have a moderate amount of erosion. The steam sealing faces on the upper and lower half are severely eroded. There is significant damage to (1) partition in the Upper Half and due to an extensive amount of erosion and through holes in many of the blades, it is warranted to complete a major weld repair to all blades in the Lower Half.

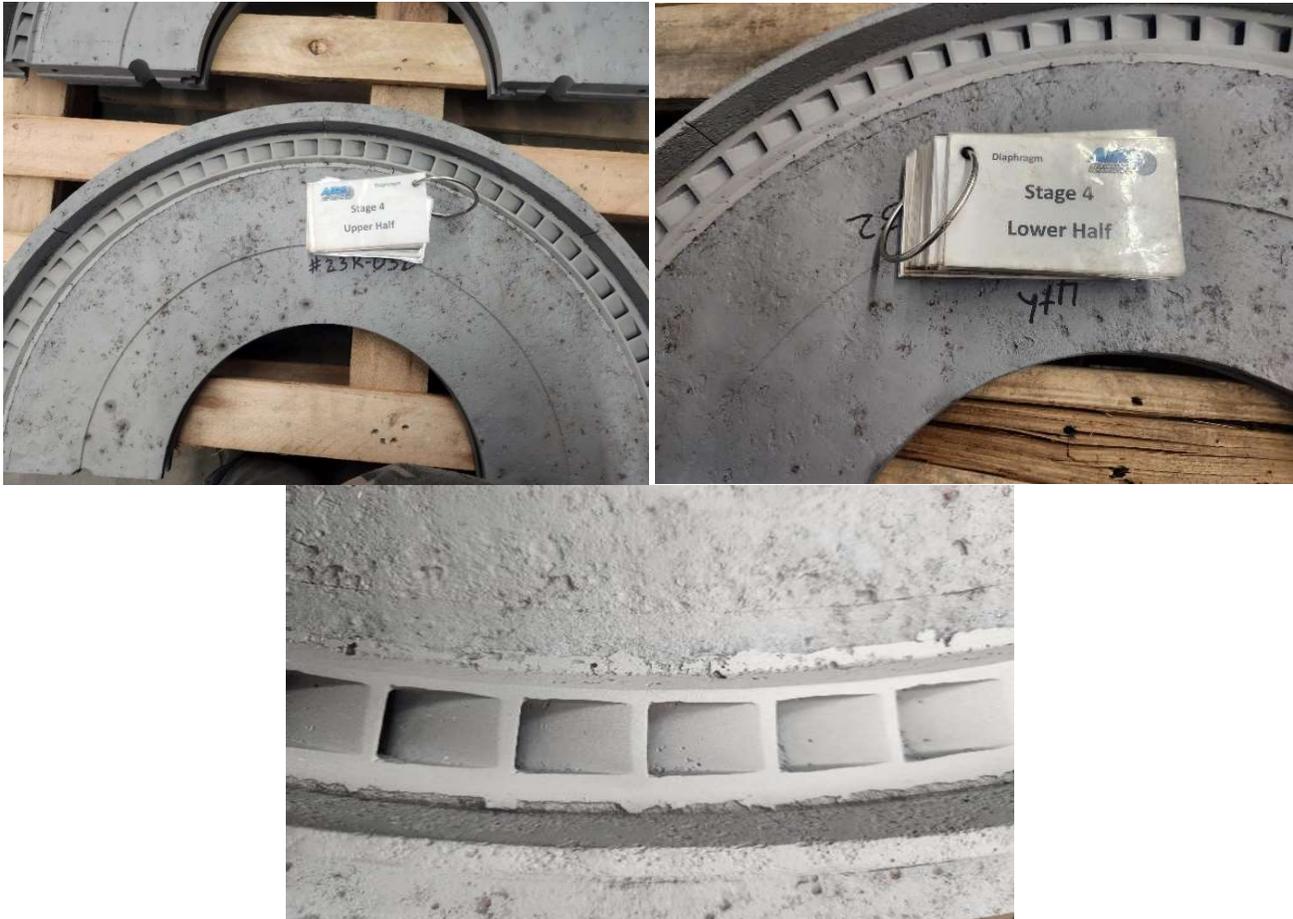
All partitions on the 4th stage diaphragm are presenting with minor amounts of pitting.
The joint, packing hooks, and keys have a moderate amount of erosion.
The steam sealing faces on the upper and lower half are severely eroded.
There is one Packing Bolt on the Upper Half that was broken prior to arrival at the AIRS Facility.

- Light Polish only all blades. (No bench backs to be performed.)
- Drill out broken packing bolt and retap.

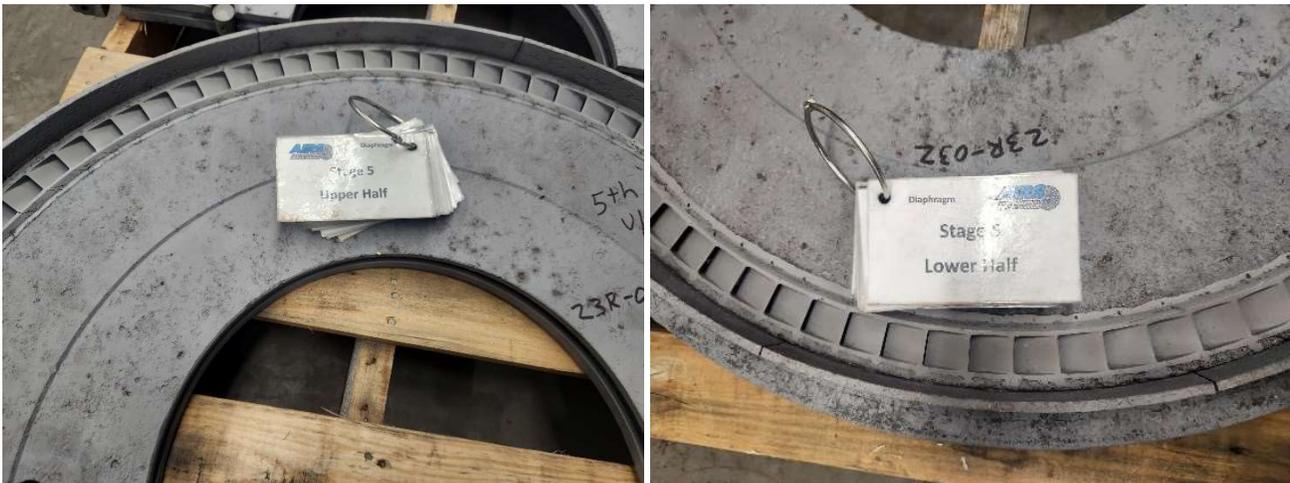
All partitions on the 5th stage diaphragm are presenting with minor amounts of pitting. The joint, packing hooks, and keys have a moderate amount of erosion. The steam sealing faces on the upper and lower half are severely eroded.

-Light Polish only all blades. (No bench backs to be performed.)

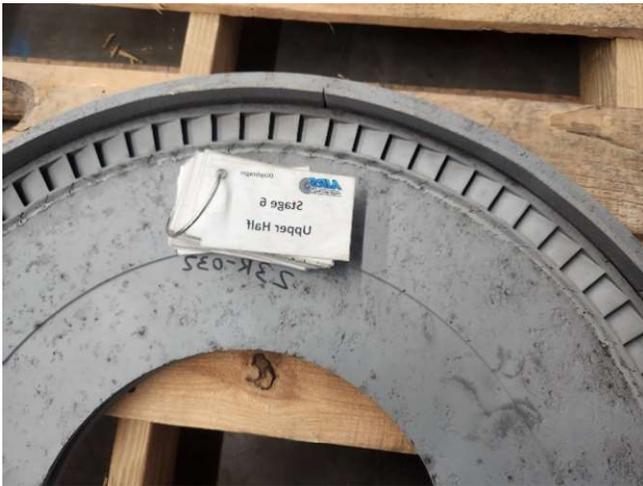
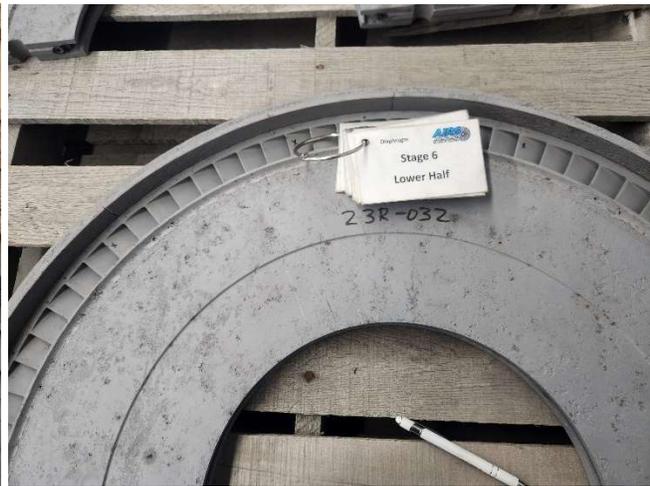
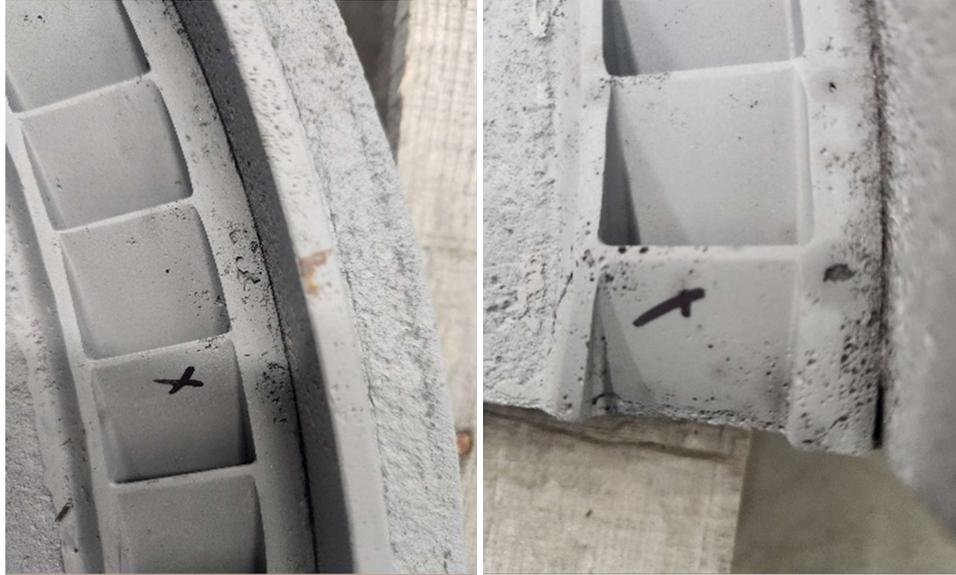
There is significant damage to (13) partitions in the Lower Half and due to an extensive amount of erosion and thru holes in many of the blades, it is warranted to complete a major weld repair in the Lower Half.

- Perform a full major repair to all blades in the Lower Half and (1) blade in the Upper Half. All blades will be cutback and new blades and sidewalls will be re-established utilizing Inconel Weld material.
- Light Polish only all blades. (No bench backs to be performed.)
- Drill out broken packing bolt and retap.

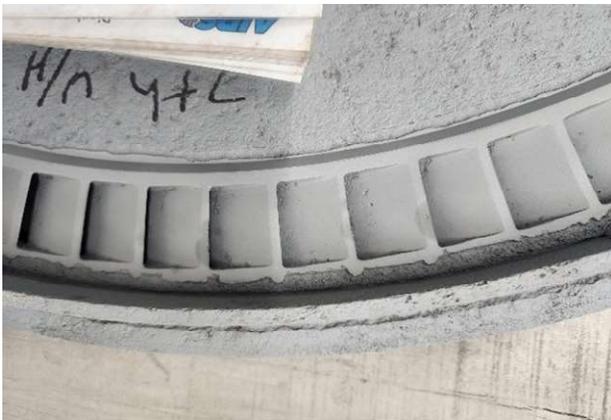
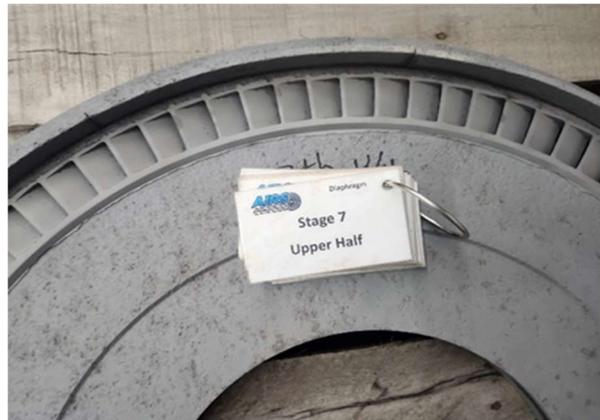
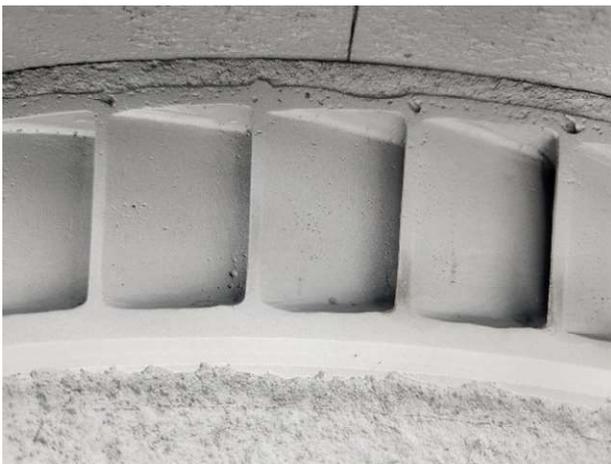
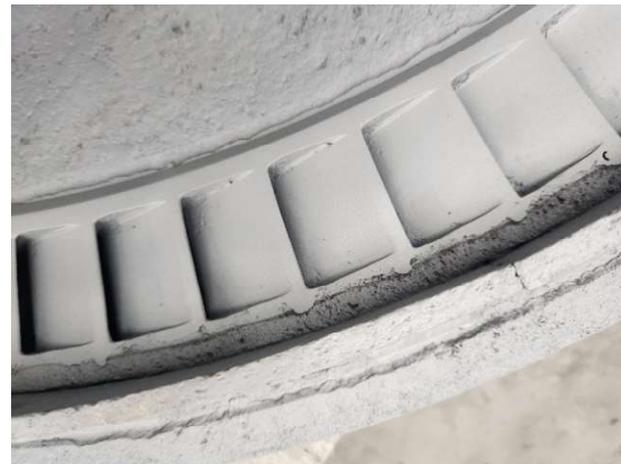
All partitions on the 7th stage diaphragm are presenting with minor amounts of pitting. The joint, packing hooks, and keys have a moderate amount of erosion. The steam sealing faces on the upper and lower half are severely eroded.

-Light Polish only all blades. (No bench backs to be performed.)

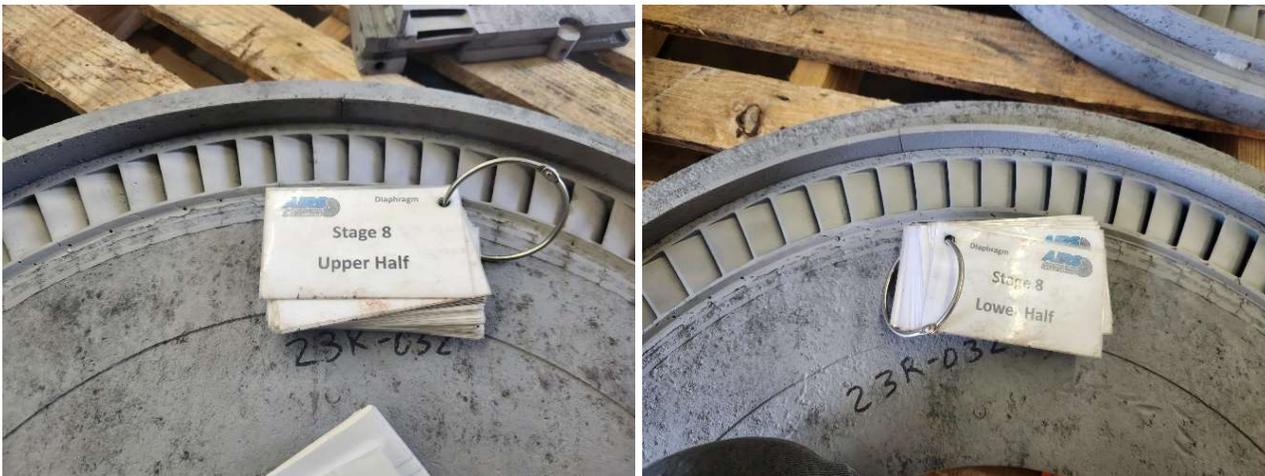
All partitions on the 8th stage diaphragm are presenting with minor amounts of pitting. The joint, packing hooks, and keys have a moderate amount of erosion. The steam sealing faces on the upper and lower half are severely eroded. There is one Packing Bolt on the Upper Half that was broken prior to arrival at the AIRS Facility.

- Light Polish only all blades. (No bench backs to be performed.)
- Drill out broken packing bolt and retap.

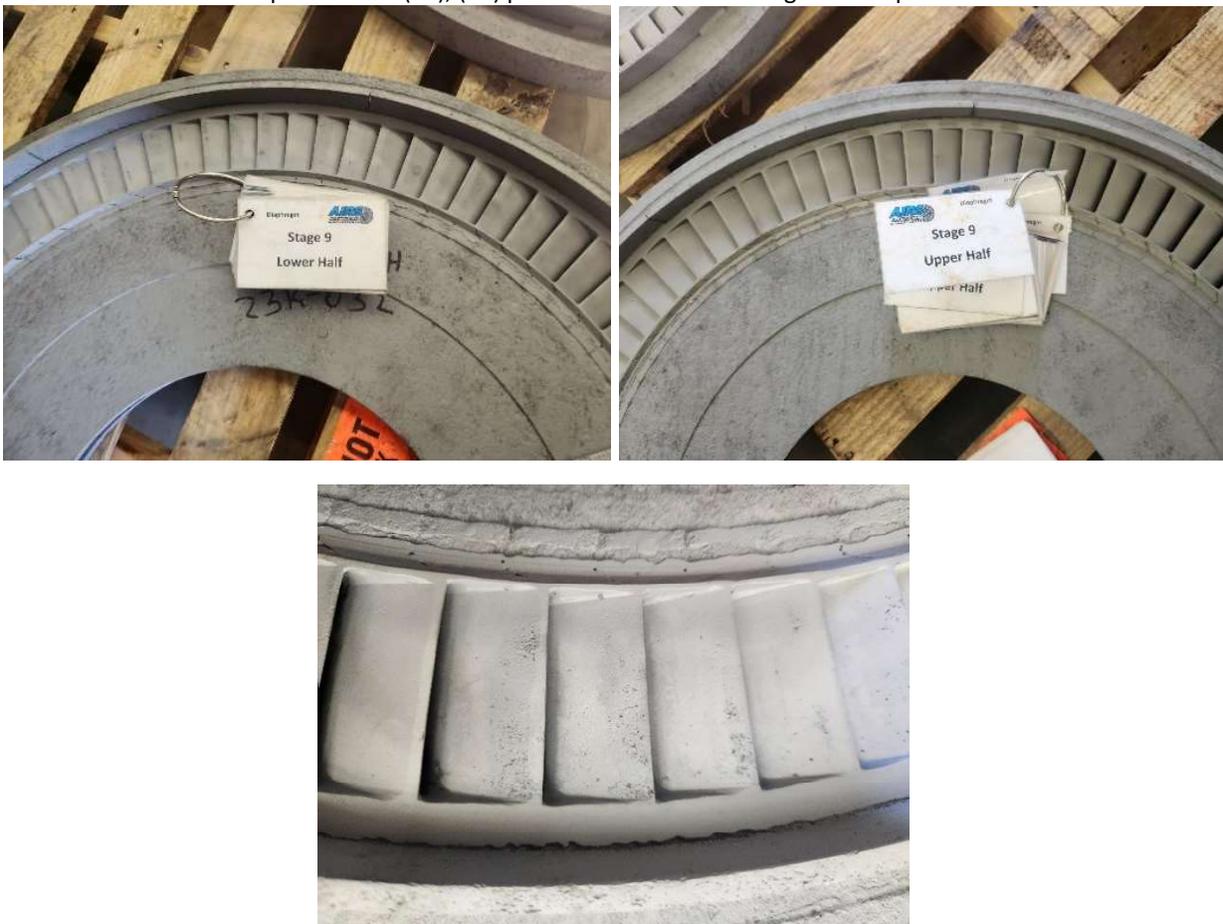
All partitions on the 9th stage diaphragm are thin and present with moderate to heavy amounts of pitting. The joint, packing hooks, and keys have a moderate amount of erosion. The steam sealing faces on the upper and lower half are severely eroded.

Benchback 0.20-0.30” and light polish all blades. (Straighten only as/if needed.)

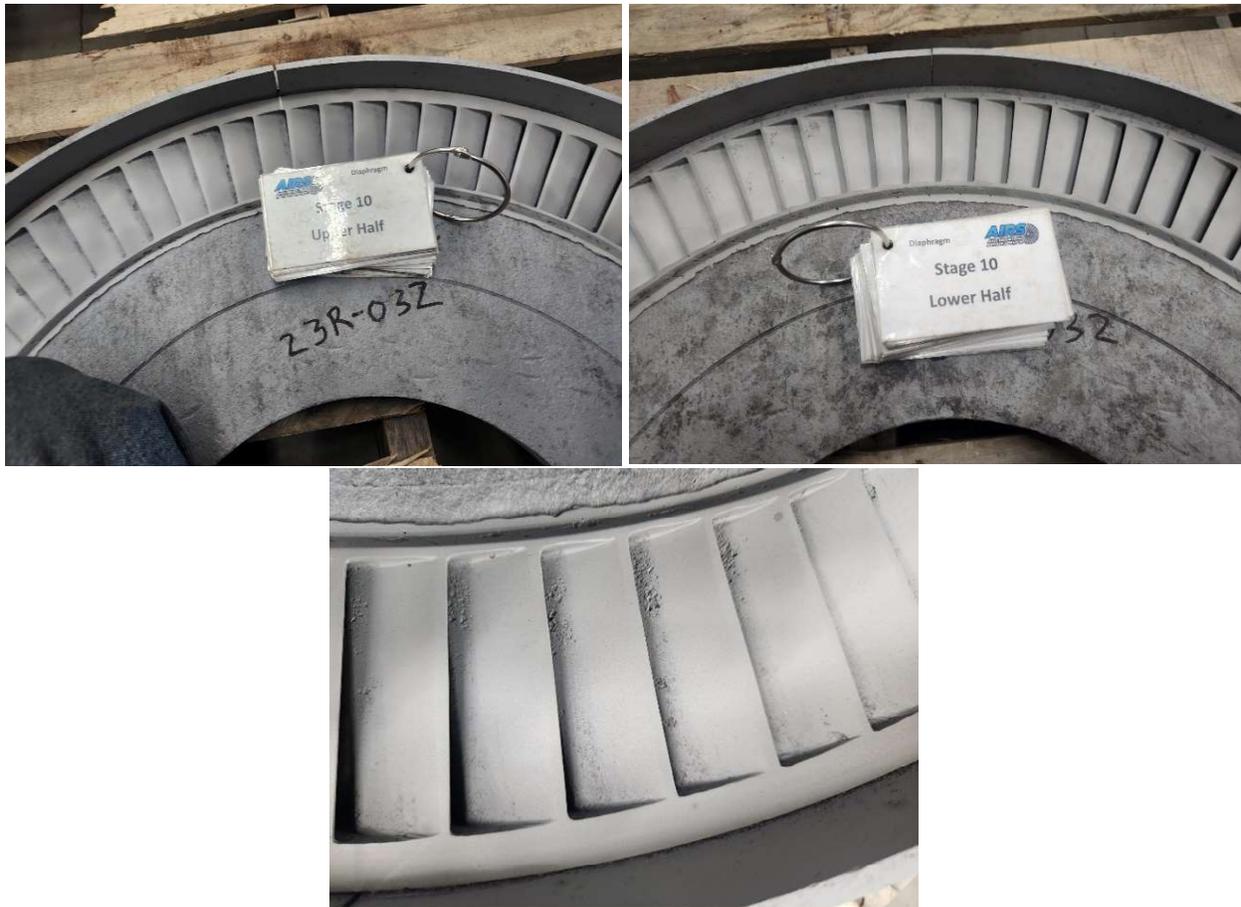
All partitions on the 10th stage diaphragm are presenting with minor amounts of pitting. The joint, packing hooks, and keys have a moderate amount of erosion. The steam sealing faces on the upper and lower half are severely eroded. There is one Packing Bolt on the Upper Half that was broken prior to arrival at the AIRS Facility.

- Benchback 0.20-0.30” and light polish all blades. (Straighten only as/if needed.)
- Drill out broken packing bolt and retap.

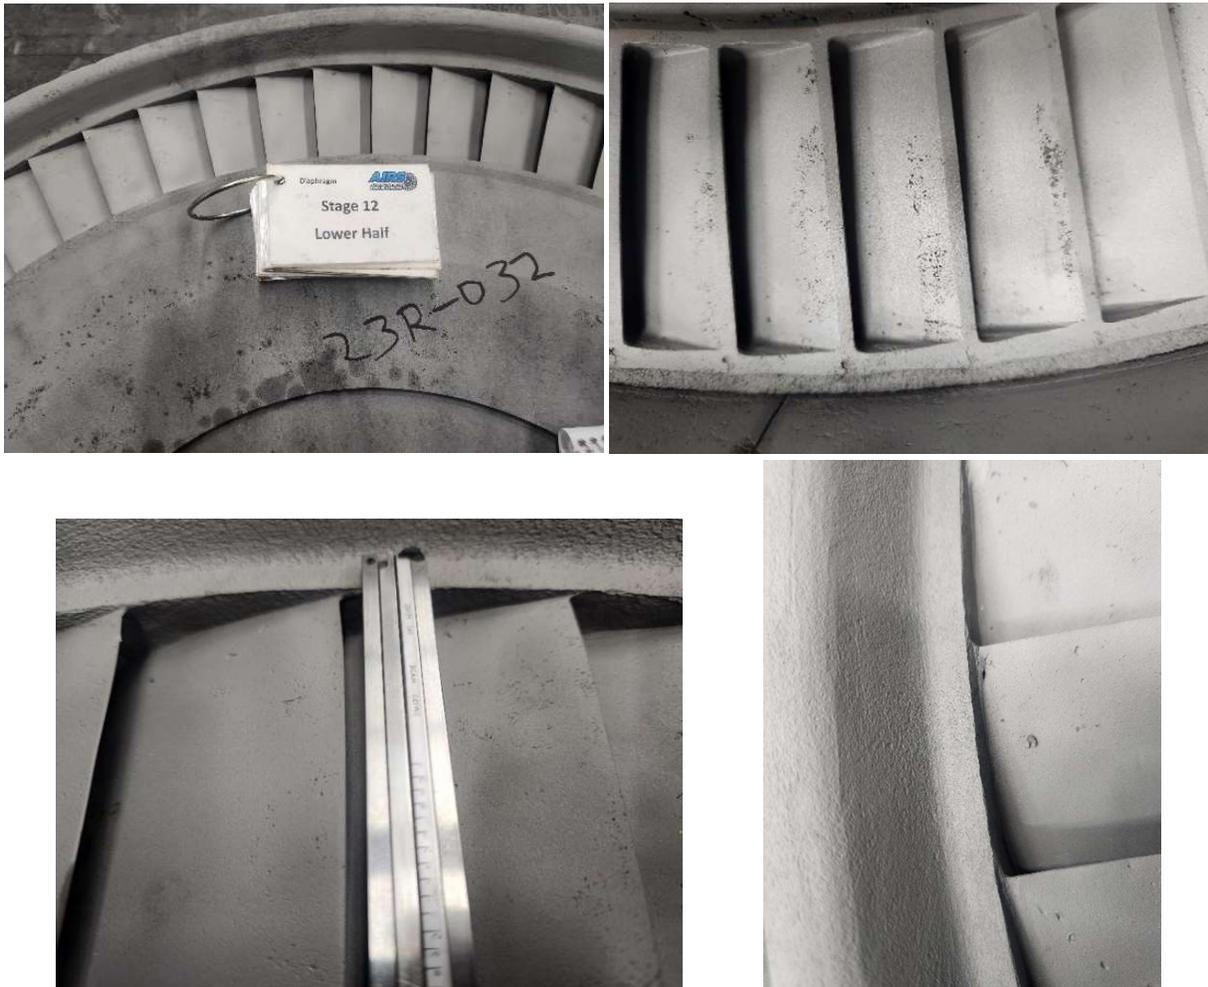
All partitions on the 12th stage diaphragm are extremely thin and present with moderate to heavy amounts of pitting. All have been cut back previously .100-.235" behind the fab line and have damaged corners on X wall. The joint, packing hooks, and keys have a moderate amount of erosion. The steam sealing faces on the upper and lower half are severely eroded.

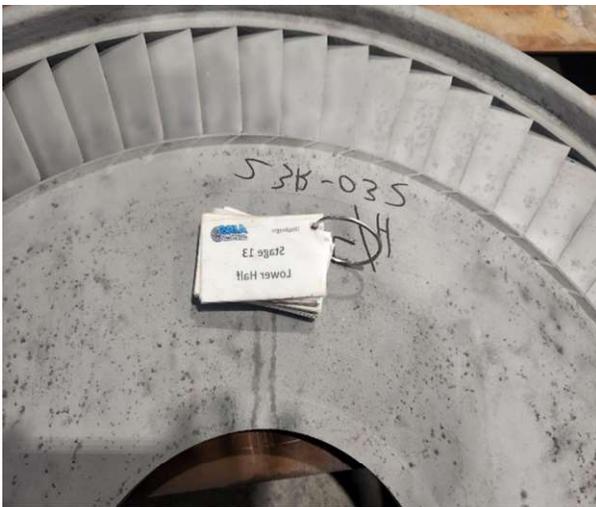
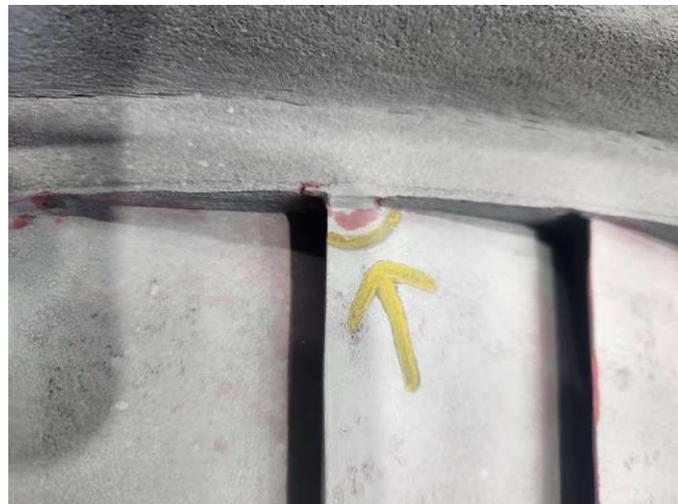
All partitions on the 13th stage diaphragm are presenting with minor amounts of pitting and a very thin at all trailing edges. There is (1) found crack on the Upper Half, partition #28 at X-wall.

- Benchback 0.20-0.30” and light polish all blades. (Straighten only as/if needed.)
- Weld Repair crack on Upper Half #28 X-wall.
- Light Polish only all blades. (No bench backs to be performed.)

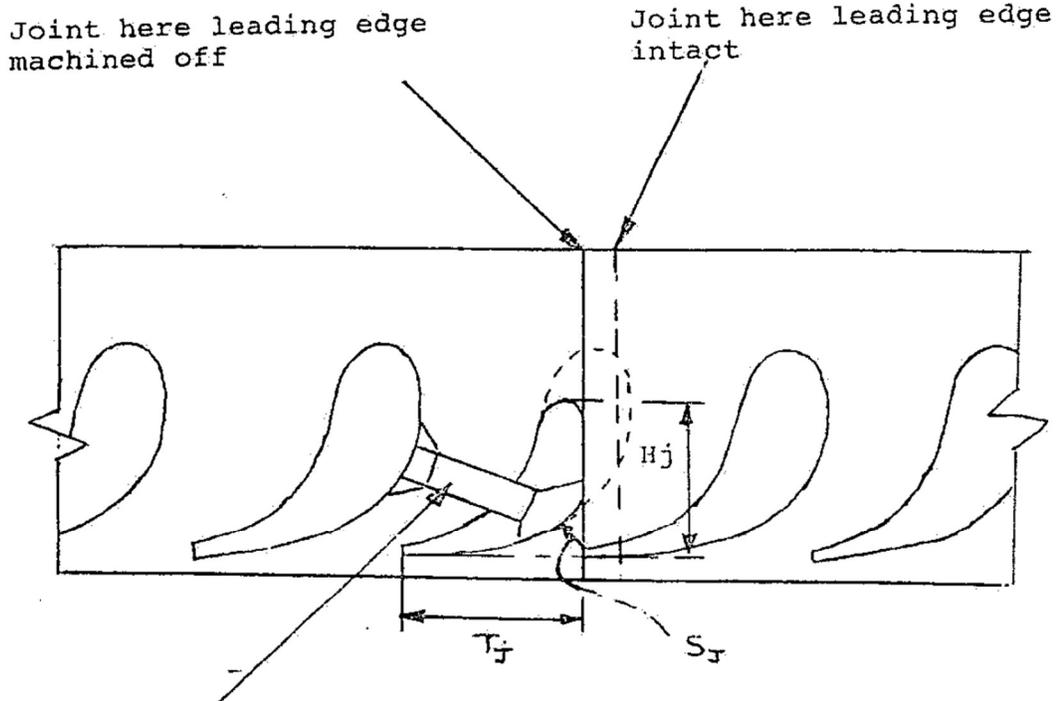
Tie Pin Type 410 - material
Welded per P8A-AL-0001 Col. M

-Install (2) Pins per Joint Partition and Weld using Inconel, to the adjacent partition. This will keep the joint blade from continuing to crack and dislodge from the current position.

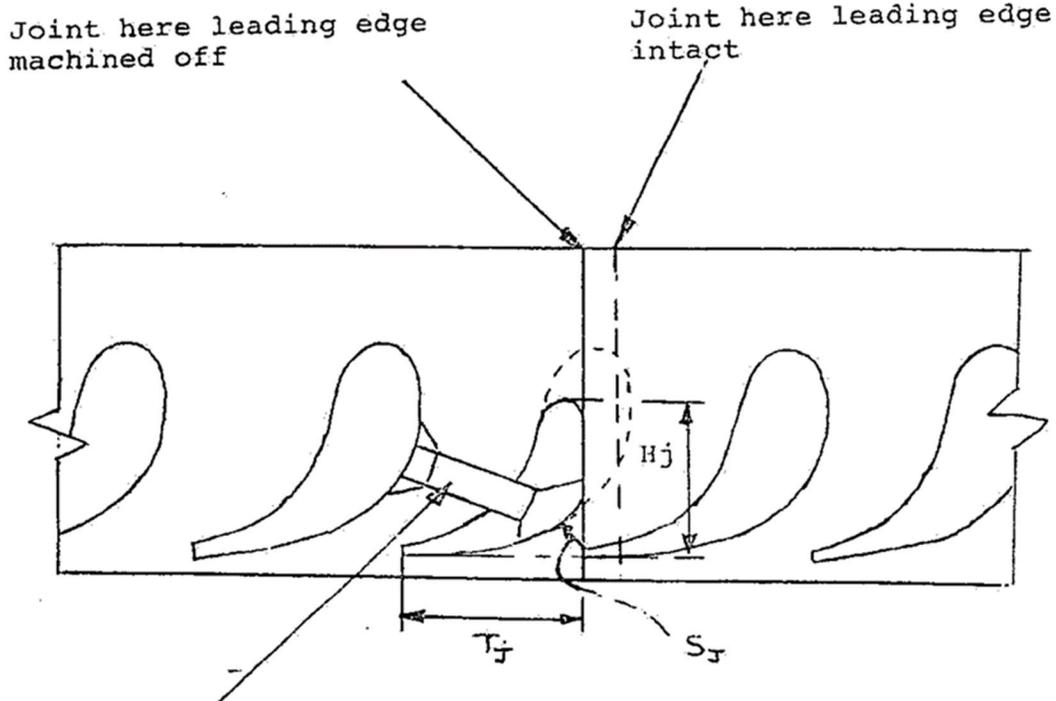
Tie Pin Type 410 - material
Welded per P8A-AL-0001 Col. M

-Install (2) Pins per Joint Partition and Weld using Inconel, to the adjacent partition. This will keep the joint blade from continuing to crack and dislodge from the current position.
